Sand Coulee Creek and Upper Tributaries **Flood Hazard Analyses**

**Cascade
County
Montana**

**SOIL CONSERVATION SERVICE
U.S. DEPARTMENT OF AGRICULTURE**

JULY 1973

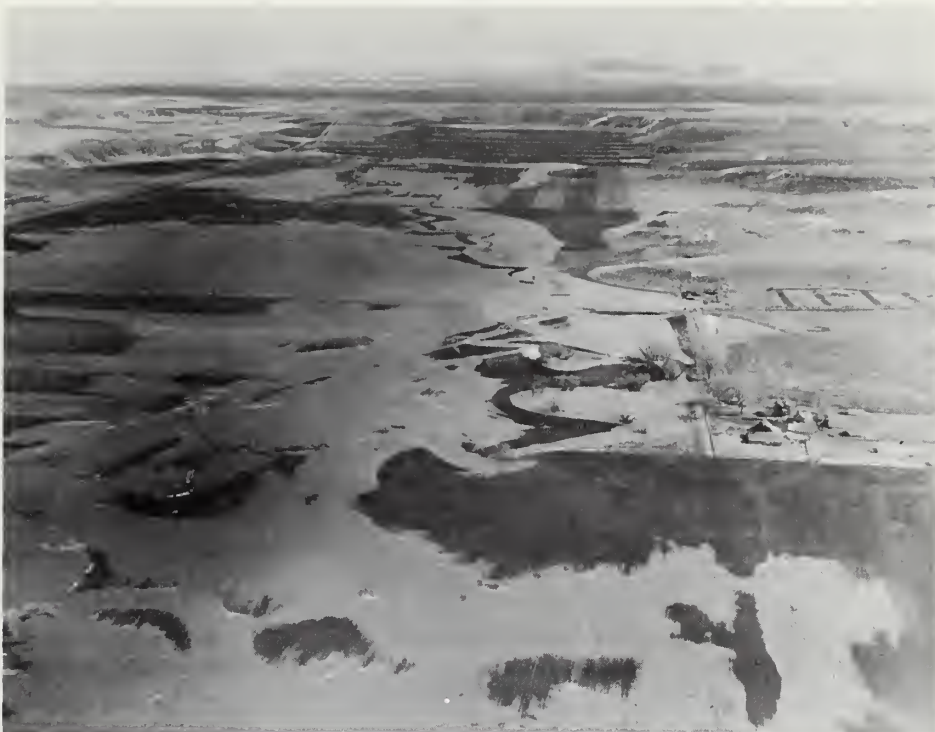
U. S. AIR FORCE PHOTO - MARCH 11, 1966

Sand Coulee Creek spreads over bottom land east of Donovan Park and the lower reaches of the flood plain. This flooding was caused by warm chinook winds which rapidly melted the snow. This is the most common cause of flooding in the area.

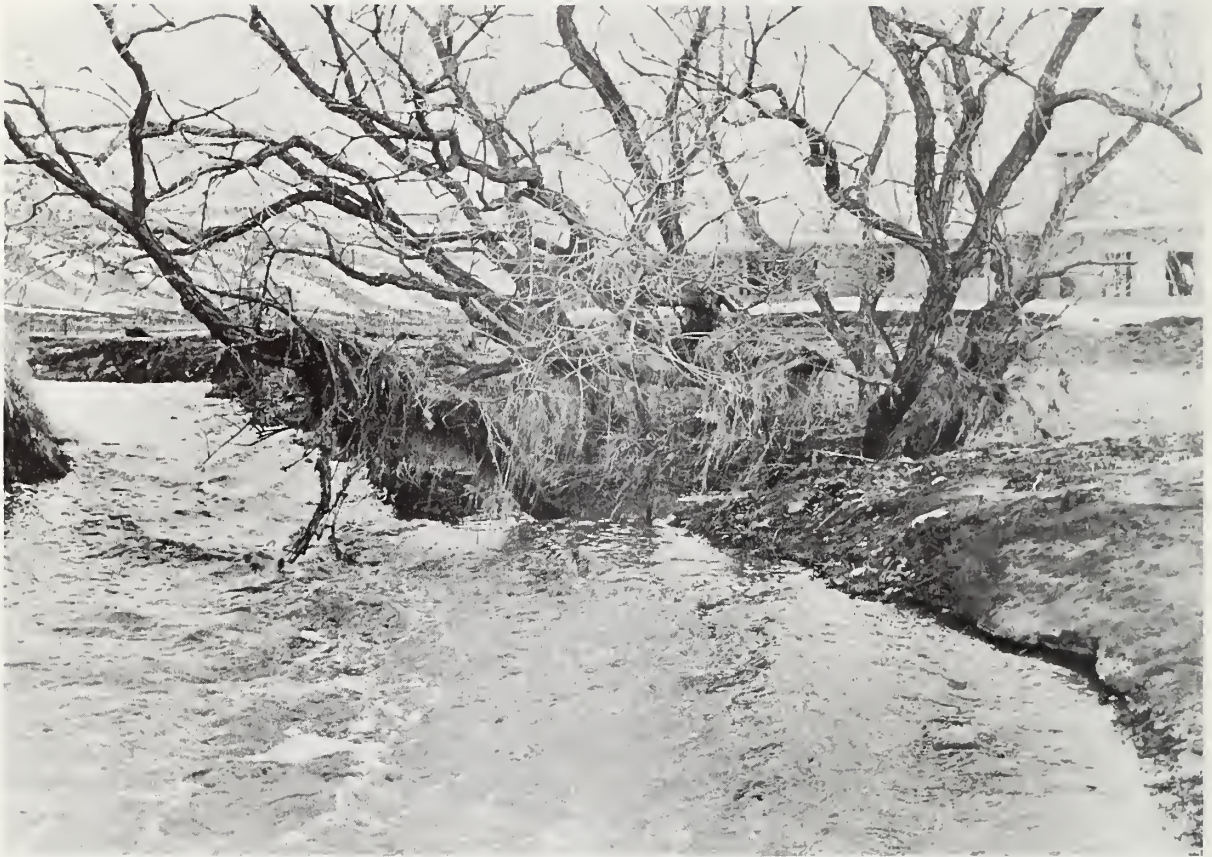
GREAT FALLS TRIBUNE PHOTO - 1969

Trash hangs in trees at Centerville as a reminder of high flood flows. Debris often plugs bridges and culverts, increasing flood damages.

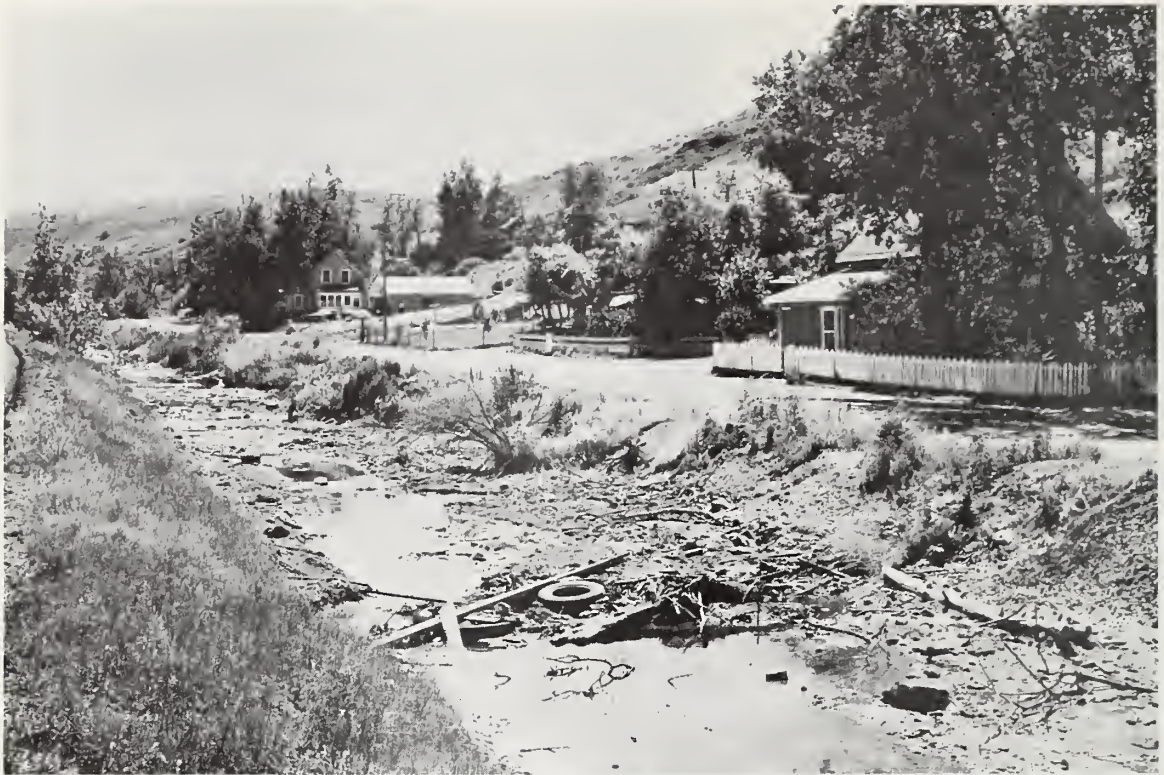
SCS PHOTO

Debris, filth, and pollution in the stream channel in the town of Sand Coulee. Sewage effluent from several homes in the residential area also discharges directly into the stream.

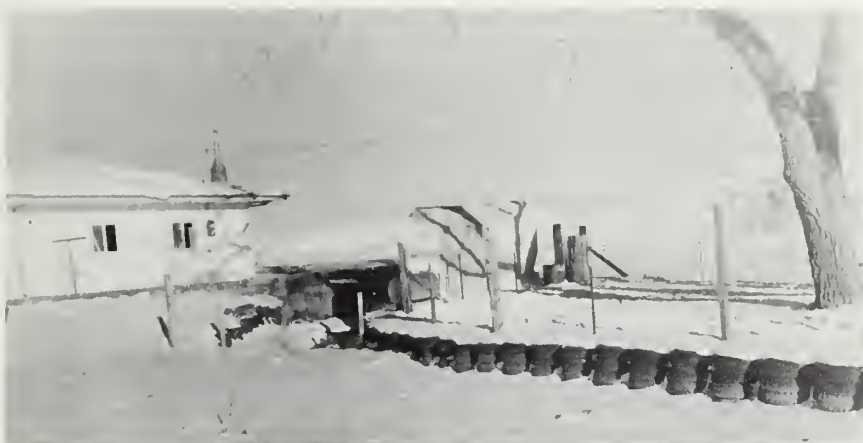
SCS PHOTO Mt-P1097-14

*Floodproofing
measures such as
dikes and walls
are not only
expensive, but
are often
inadequate for
large storms.*

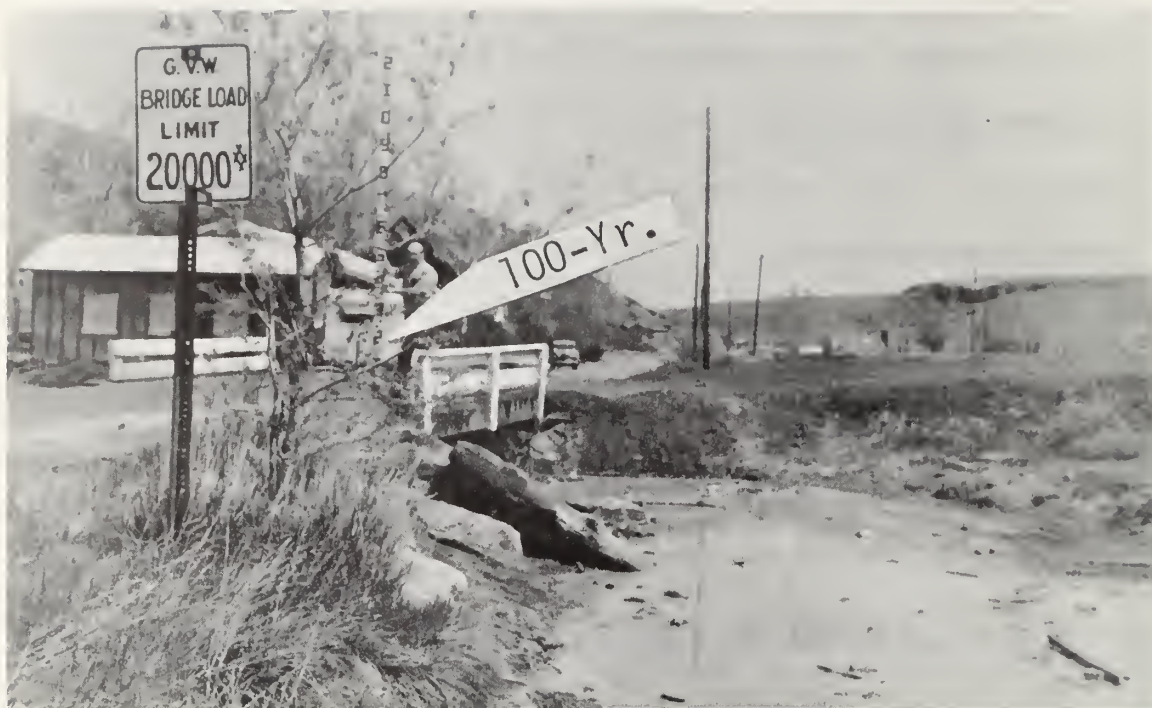
SCS PHOTO 11-022-B-10

*Depth of 100-year frequency flood over bridge 326 in Sand Coulee.
(Valley Cross Section No. 95)*

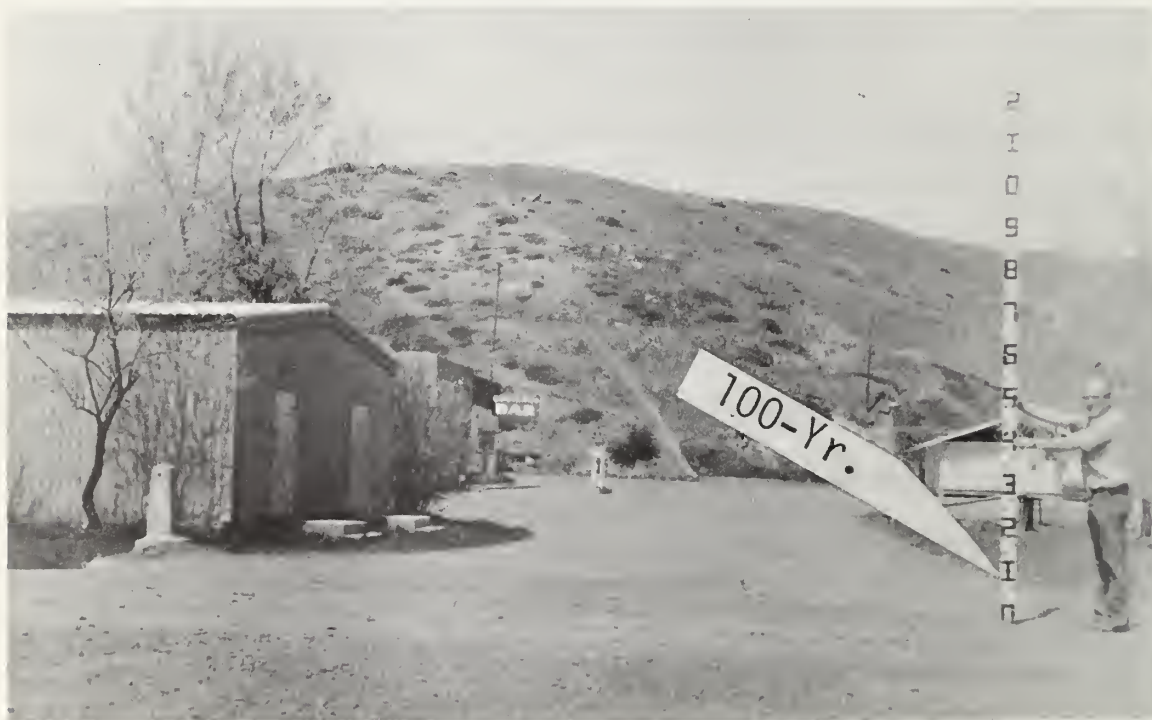
SCS PHOTO 11-022-B-9

*Depth of 100-year frequency flood one block south of the Sand
Coulee Post Office. (Valley Cross Section No. 90)*

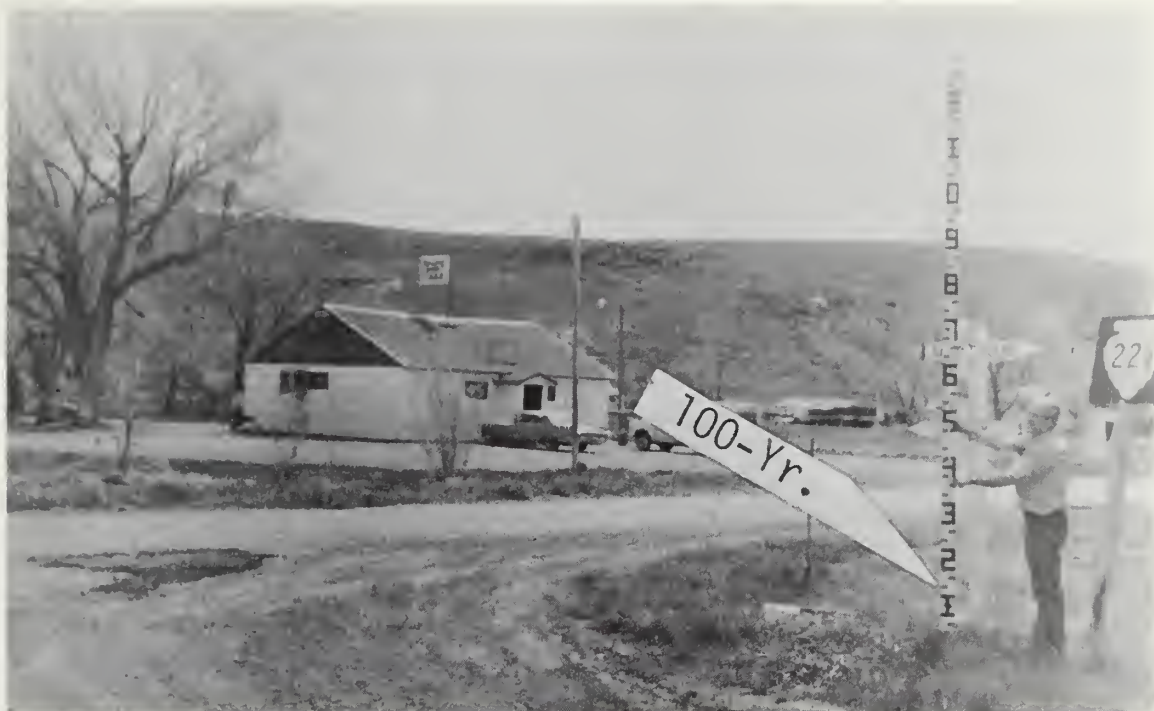
SCS PHOTO 11-022-B-13

Depth of 100-year frequency flood at the road intersection of the Sand Coulee Road and Tracy Road near Tracy. (Valley Cross Section No. 45)

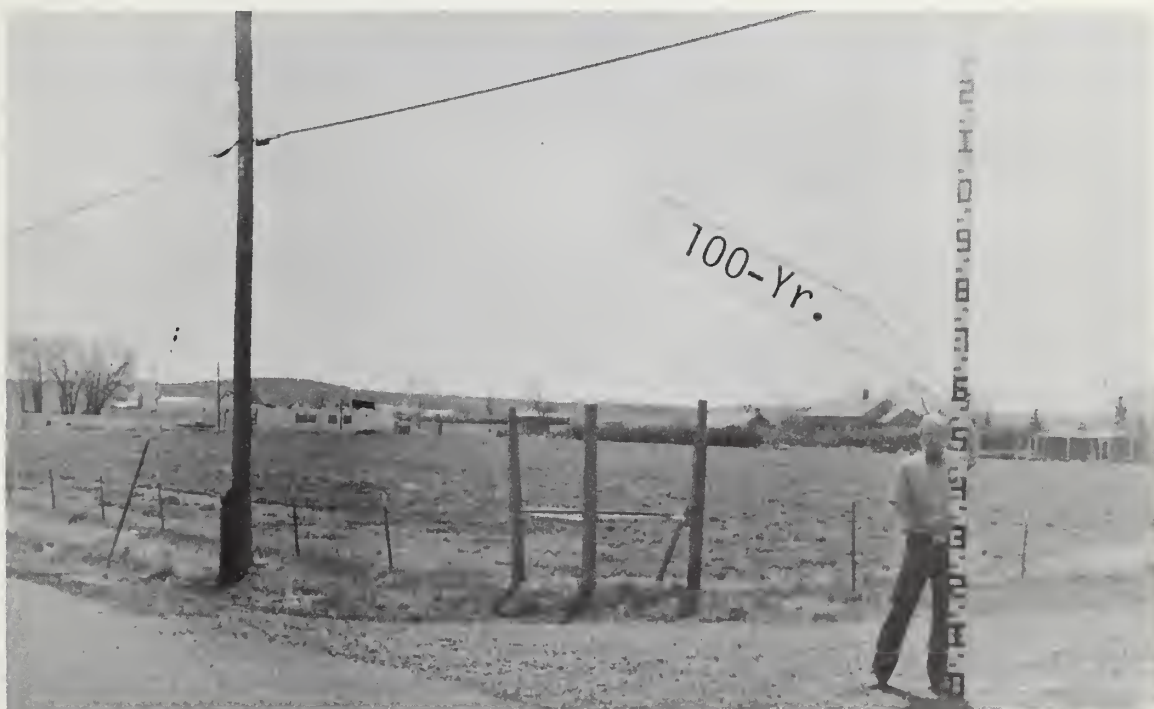
SCS PHOTO 11-022-B-6

Depth of 100-year frequency flood along Gibson Flats Road and Eaton Avenue-looking southeast.

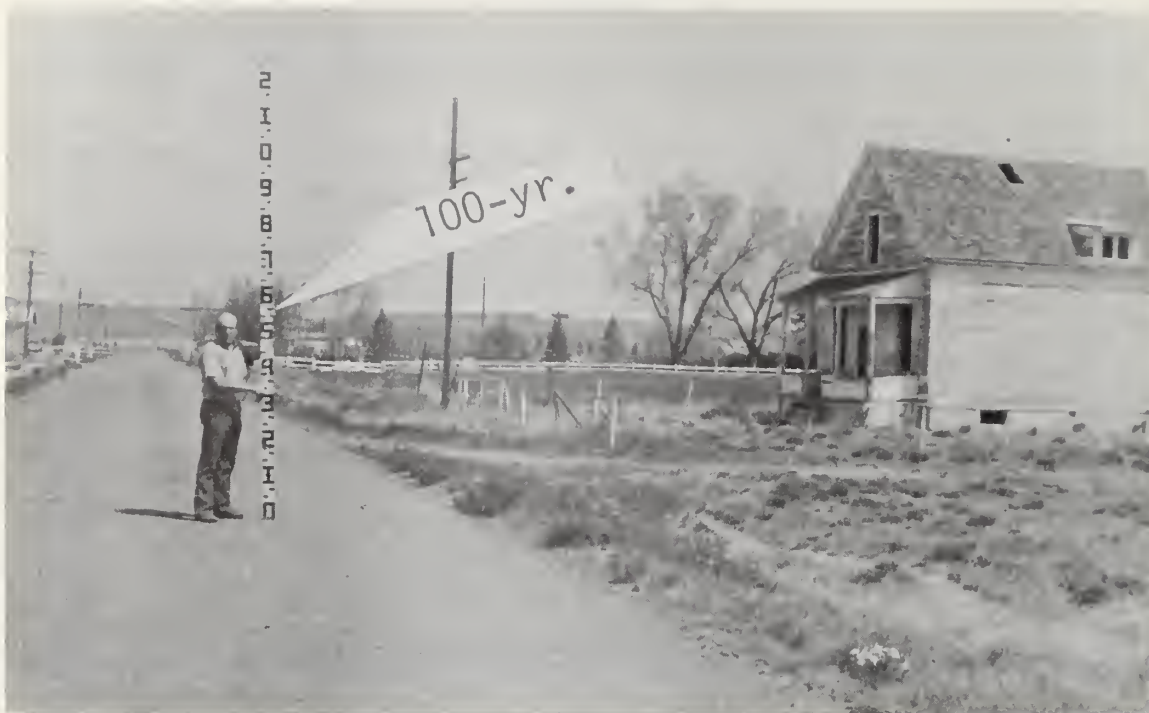
SCS PHOTO 11-022-B-7

Depth of 100-year frequency flood in Gibson Flats-looking north on Eaton Avenue.

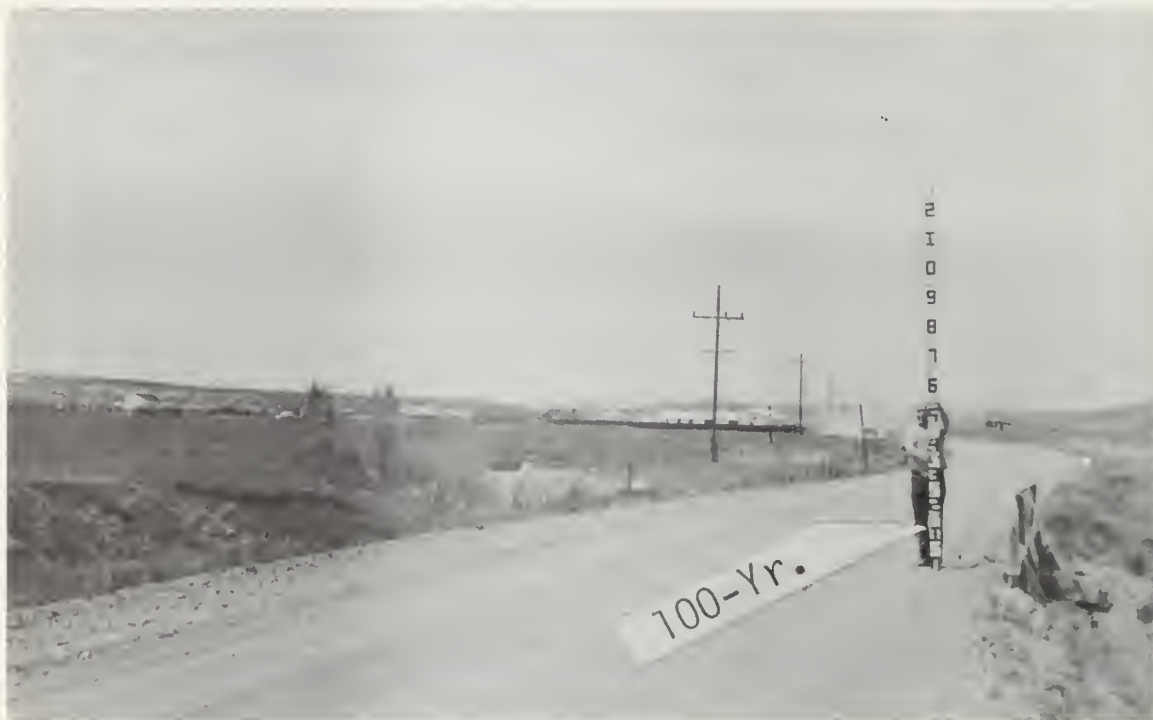
SCS PHOTO 11-022-B-14

Depth of 100-year frequency flood at the first bridge east of Fields on Fields Road. (Valley Cross Section No. 18)

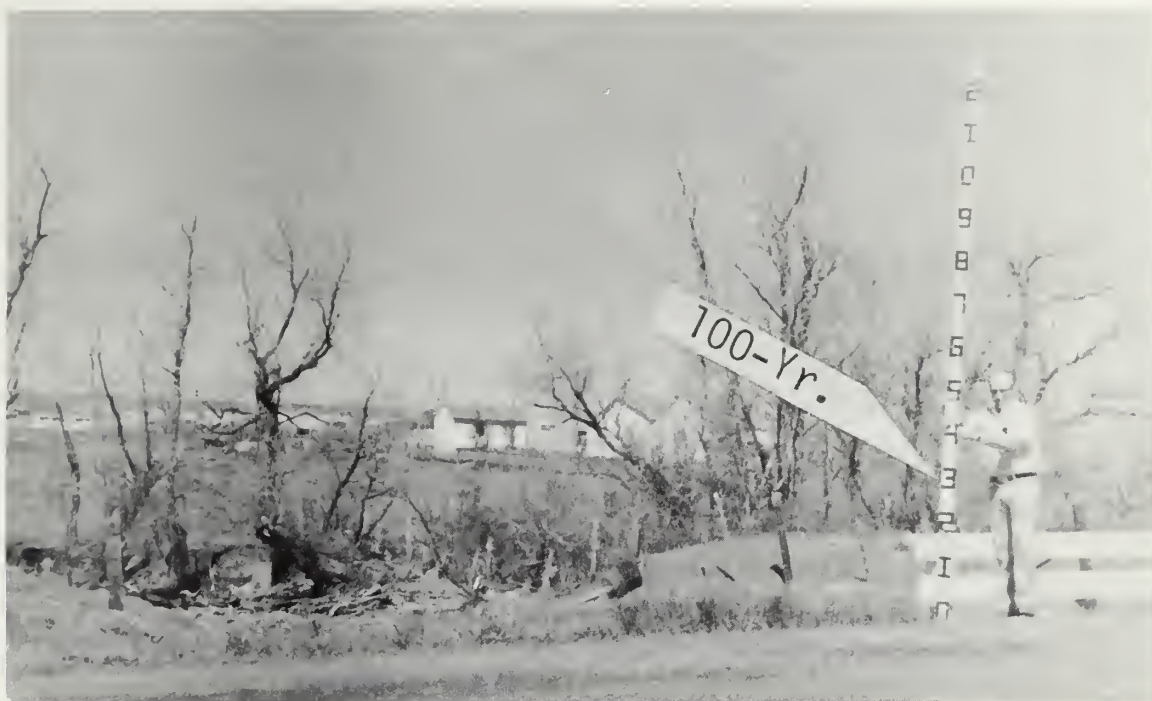
SCS PHOTO 11-022-7

Depth of 100-year frequency flood at the bridge over Sand Coulee Creek on Ayrshire Dairy Road. (Valley Cross Section No.8)

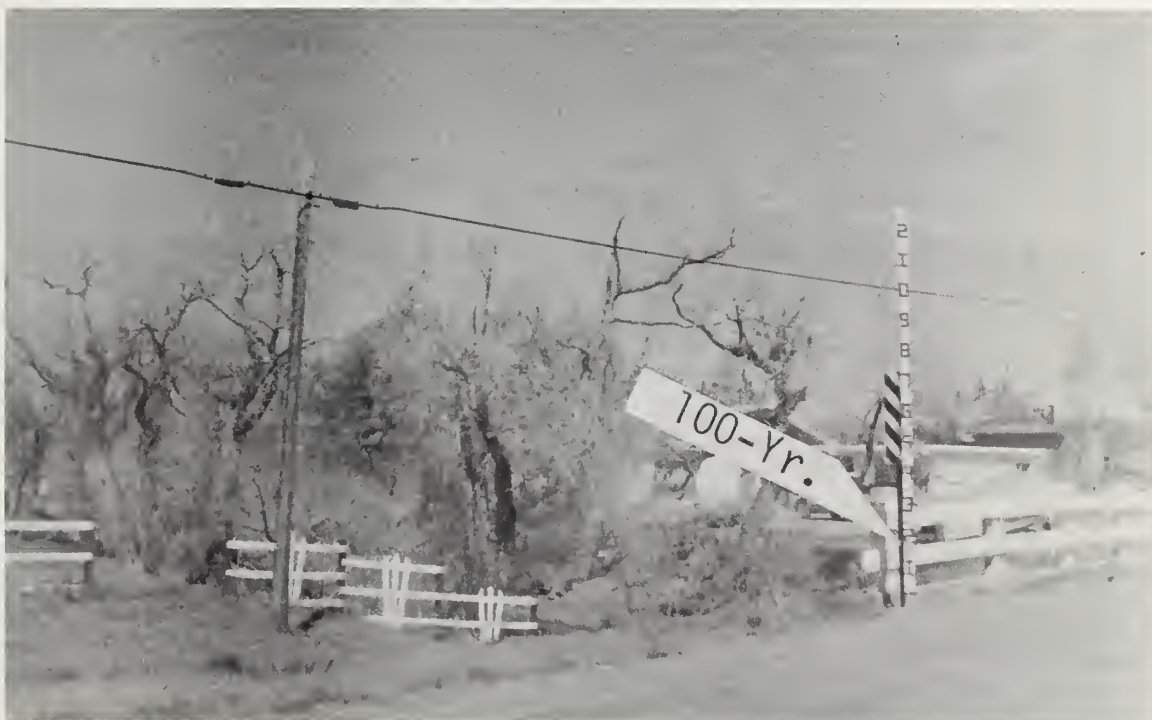
SCS PHOTO 11-022-5

Depth of 100-year frequency flood at bridge on River Drive Road over Sand Coulee Creek. (Valley Cross Section No. 2)
